## **A. SSO Inventory (from Town of Ludlow IDDE)**

**Town of Ludlow BMP Tracking**

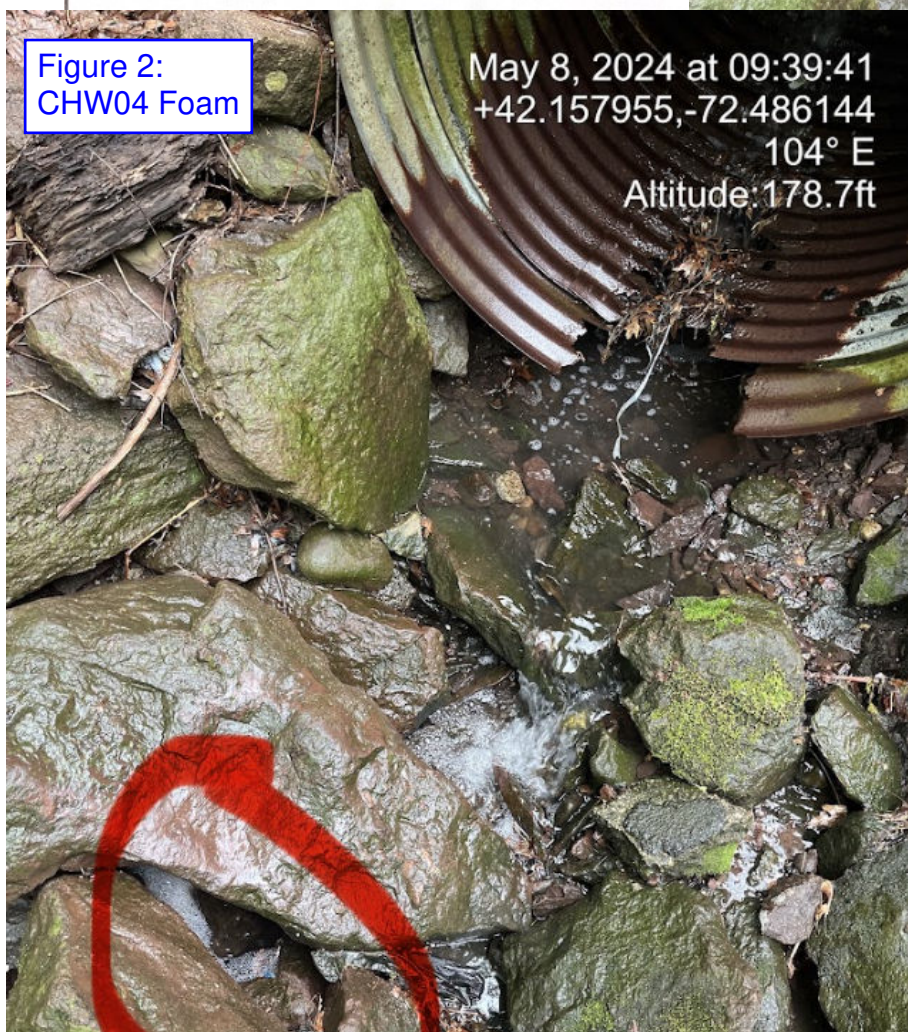
Figure 2:  
CHW04 Foam

were identified (0.10 mg/L > 0.02 mg/L). Additionally, although there was not an overt olfactory or visual evidence of sewage, foam was noted at the outfall.
