HARRIS BROOK ELEMENTARY SCHOOL

Description of Facility: Harris Brook Elementary School is a masonry 2-story building which serves as a public school for Grades 2 – 5 serving approximately 600 students. The roughly 115, 00 s.f. building was constructed in 2021.

Harris Brook Elementary School Accessibility Assessment Photos

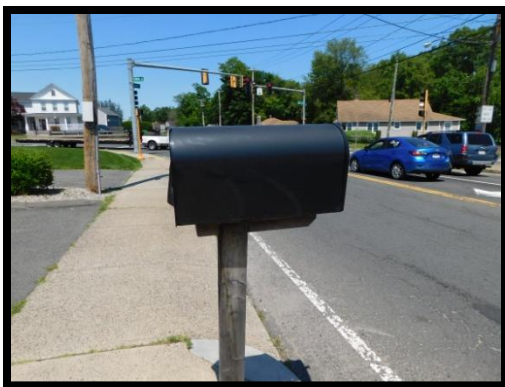
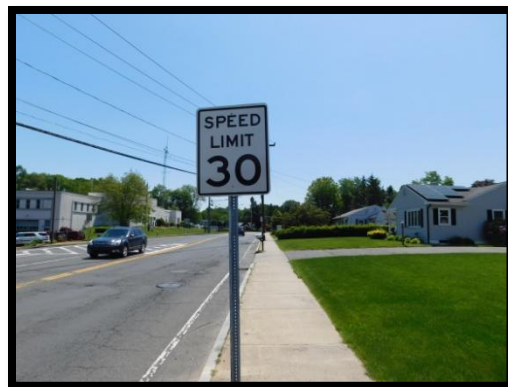
- Mailbox near House #607 (6" protrusion at 42" a.f.f.).
- 30 MPH sign near House #607 (10 1/2" protrusion at 72" a.f.f.).
- Mailbox near House #605 (6" protrusion at 45" a.f.f.).
- Mailbox near House #601 (8" protrusion at 41 1/2" a.f.f.).
- 13' 11" sign near House #597 (11" protrusion at 22" a.f.f.).
- PVTa temporary bus stop sign across from apartment building near East Street (11 1/2" out at 42" a.f.f.).
- Sidewalk across from high school reduced headroom of less than 80" due to vegetative overgrowth.

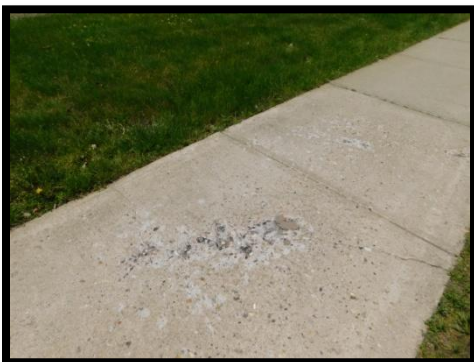
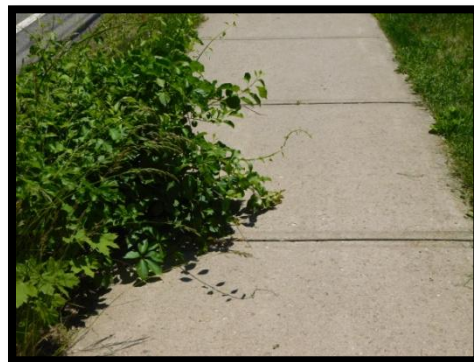
- The sidewalk near House #493 has 2 areas of deterioration resulting in abrupt changes in level surface.
- Vegetative overgrowth into the sidewalk near House #417 reduces the clear width to only 32\"/>

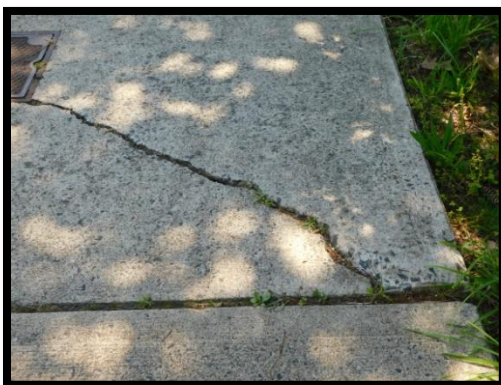
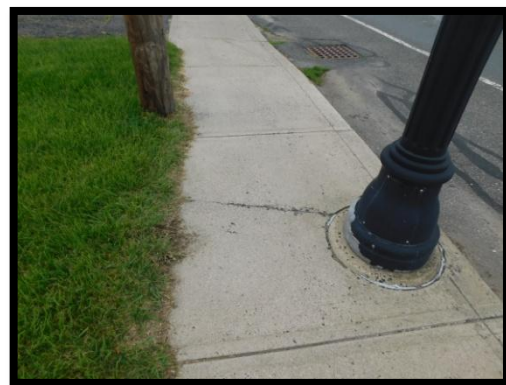
- The sidewalk has 2 abrupt changes in level surface and raised concrete pads near the crosswalk across East Street.
- There is a 1/2" abrupt change in level surface at Pole #571.
- There is only 32" of clear width at the telephone pole in front of the Faith Community Chapel Church.
- There is only 30" of clear width as well as a 3" abrupt change in level surface at Pole #68/52 Eversource.
- There is only 29" of clear width at light pole near House #453.
- There is only 31" of clear width at Pole #68/43 Eversource.
- There is only 34" of clear width at light pole near House #423.
- There is only 34" of clear width at light pole near Chin's Kitchen.
- There is a 1/2" abrupt change in level surface at the PACC driveway due to concrete heaving.
- There is only 30" of clear width at Pole #VZ 35 near the PACC.

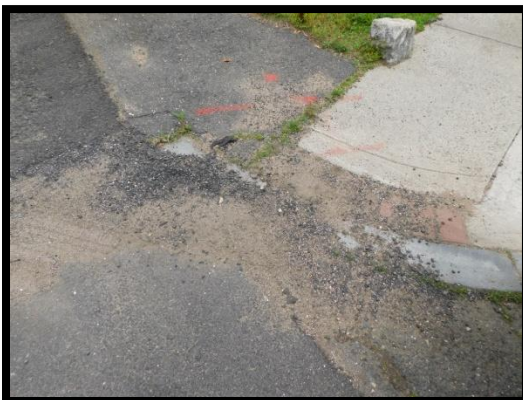
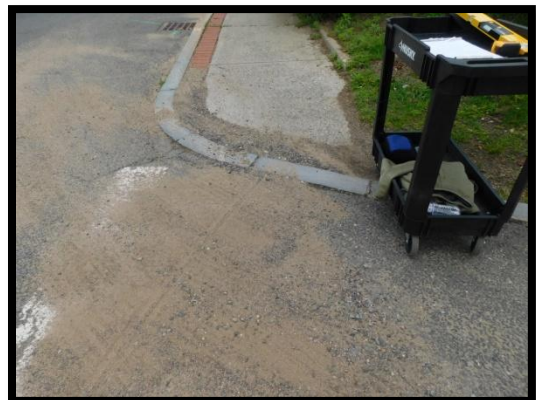
- King Street (#619 side).
- Cedar Street (church side).
- Kirkland (#423 side).

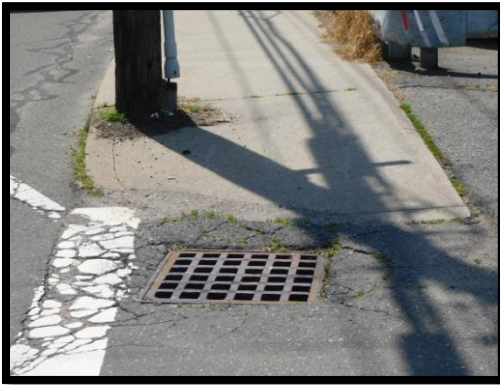
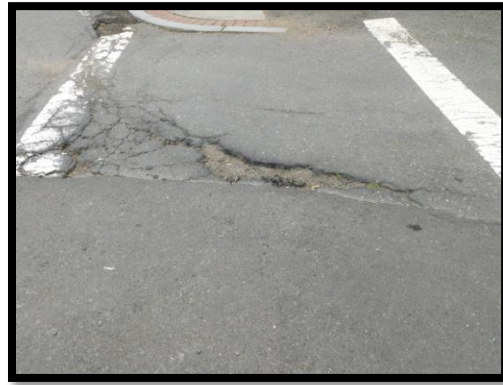
- Amherst Street (storm grates).
- Pine Street (asphalt deterioration w/2" abrupt change in level surface).
- Hubbard Street (storm grates).

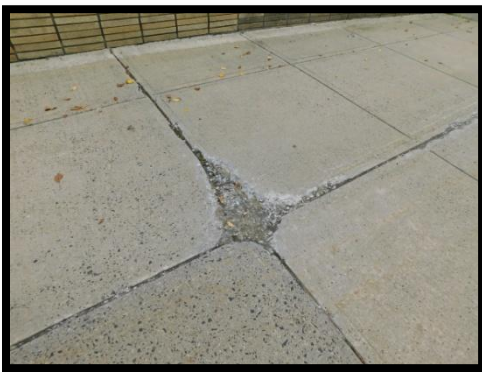
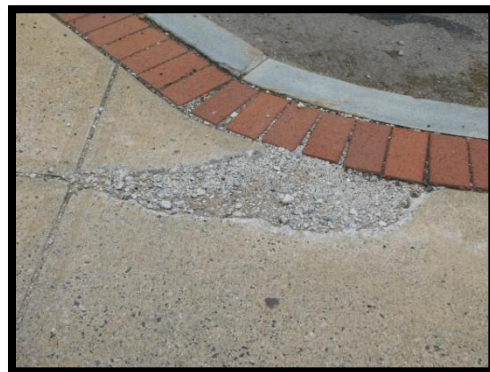
- There are 3 areas of concrete deterioration with up to 2" abrupt changes in level surface at #246.
- There is concrete deterioration with up to 1" abrupt changes in level surface at #378/380.
- The sidewalk near the Brookfield Street curb ramp and #398 has a concrete pad that is heaving causing a 1/2" abrupt change in level surface. Additional concrete deterioration and abrupt changes occur at #398.
- There is up to 1/2" abrupt changes in level surface at #554.
- Reduced clear width at light pole near #554.
