# **Town of Ludlow**

## **Self-Evaluation and Transition Plan**

### **June 2025**

# **TOWN OF LUDLOW – SELF-EVALUATION AND TRANSITION PLAN**

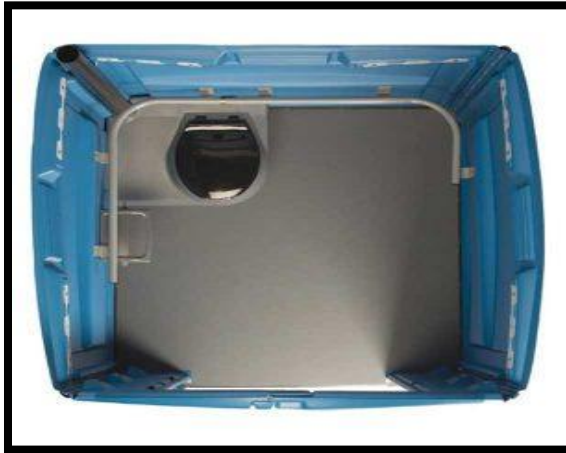
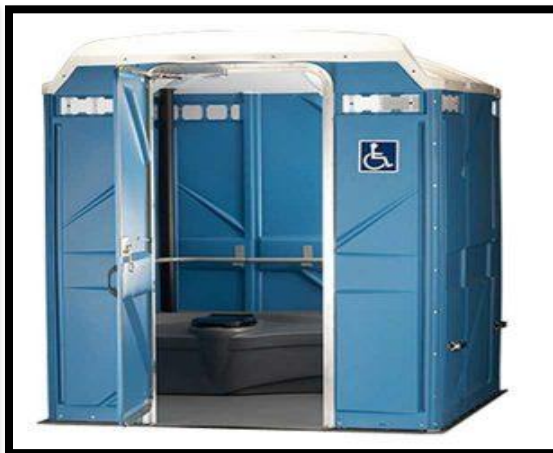
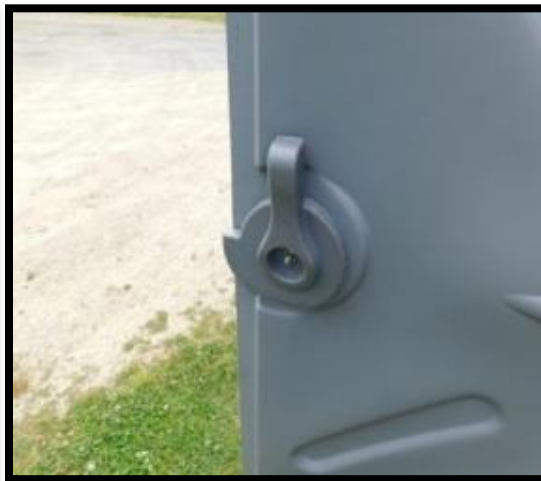
### Representative Examples of an ADA Compliant Portable Toilet

If the Town provides portable toilets for short-term events or for seasonal use, then they must be “ADA Compliant”. **An important distinction to note is that “ADA Compliant” is not synonymous with “Wheelchair Accessible.”** Wheelchair Accessible usually indicates a ramped or ground level entrance with a wide enough door for a wheelchair to gain entry. Clearances; setbacks; and dispenser, grab bar, and water closet heights do not necessarily meet ADA or 521 CMR Standards. “ADA Compliant”, however, generally means reinforced construction; a ramped or ground level and wheelchair accessible entrance; spring loaded magnetic door that closes automatically; reinforced grab bars; dispensers, grab bars, and the water closet at the proper height and near, far, and front setbacks; compliant door hardware; and enough interior space for a wheelchair to make a 360 degree turn that all fully comply with the 2010 ADA Standards and/or 521 CMR, whichever is more stringent. Illustrative examples of an “ADA Compliant” portable toilet are shown below.

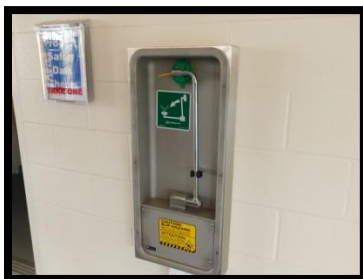
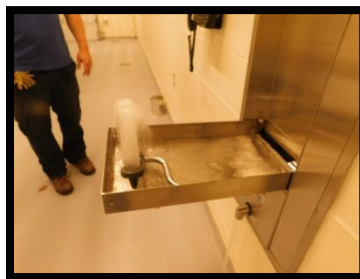
- When a shower/eyewash station is a combination unit, the eyewash should be about 14 inches from the wall to the center-line of the eyewash.
- ADA guidelines state that at least one out of five eyewash or shower stations in a specific area, or at least one, must meet ADA requirements.

Photographic examples of compliant emergency eyewash stations are provided below.

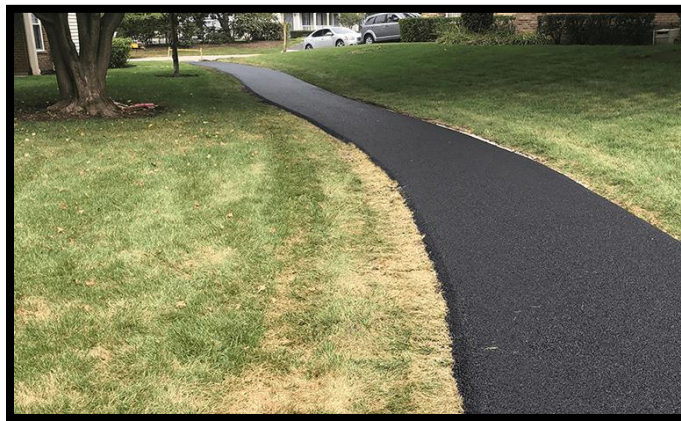
Estimated cost per square foot (2022): Up to \$10.00.

- Pros:
- 1) Durable
  - 2) Relatively inexpensive
  - 3) Requires little maintenance
  - 4) Does not readily deteriorate and has a longer live span
- Cons:
- 1) Is not permeable
  - 2) Subject to heaving and grass/weed infiltration in cracks
  - 3) Added cost due to site preparation requirements
  - 4) Requires periodic crack-filling and re-sealing/re-coating

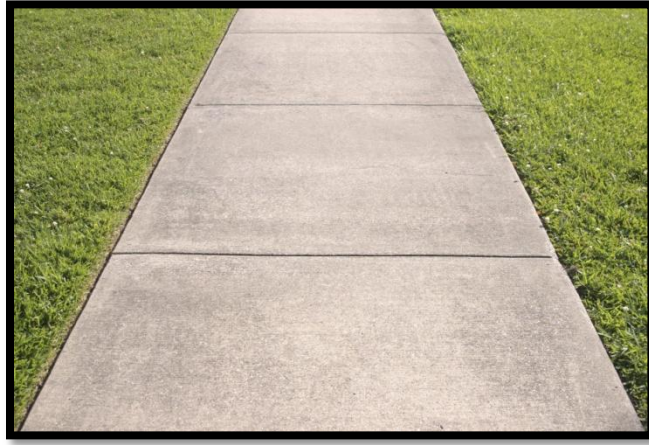
### **Concrete**

Estimated cost per square foot (2022): Up to \$25.00.

- Pros:
- 1) Durable
  - 2) Requires little maintenance
  - 3) Does not readily deteriorate and has a longer live span
- Cons:
- 1) Is not permeable
  - 2) Subject to cracking, edge deterioration, and some heaving

- 3) Is more expensive due to site preparation and construction
- 4) Requires more expensive repair varying from grinding to complete concrete pad replacement

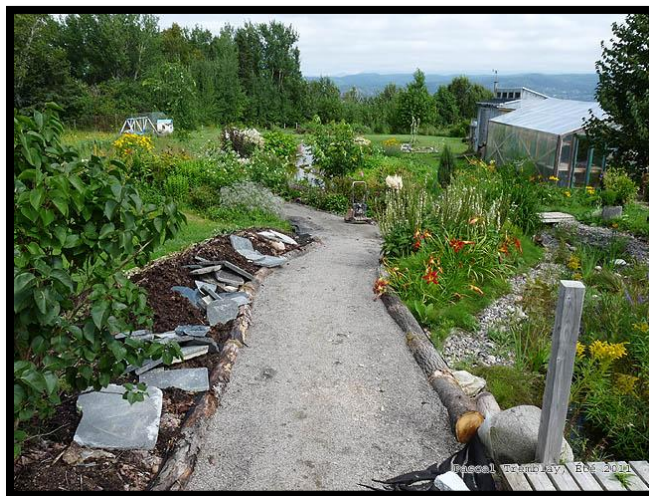
### **Stone Dust**

Estimated cost per square foot (2022): Up to \$5.00.

- Pros:
- 1) Inexpensive and can be installed by municipal work force
  - 2) Permeable
- Cons:
- 1) Requires regular maintenance including the addition of material, compaction, re-grading, and weed removal
  - 2) Subject to deterioration and wash-outs especially on sloped areas
  - 3) If not installed properly and/or regularly maintained, can be problematic for wheelchair users as well as those with arm crutches due to degradation of the surface stability and firmness

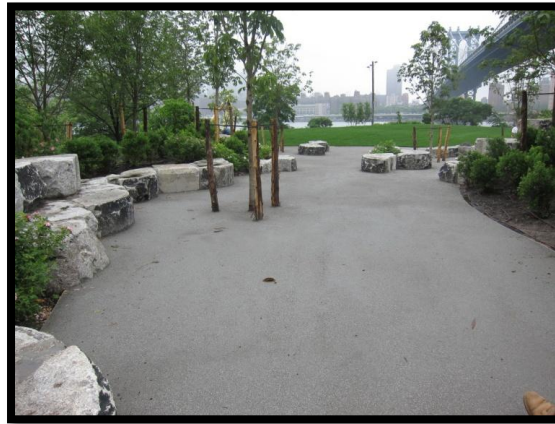
### **Stabilized Stone Dust**

Estimated cost per square foot (2022): \$7.00 to \$10.00.

- 2) Permeable
- 3) More durable than regular stone dust
- 4) Doesn't heave, weed resistant

- Cons:
- 1) Costs more than regular stone dust
  - 2) Requires metal or wood edging to preserve the integrity of the walkway and limit side erosion
  - 3) May require periodic touch up and restoration

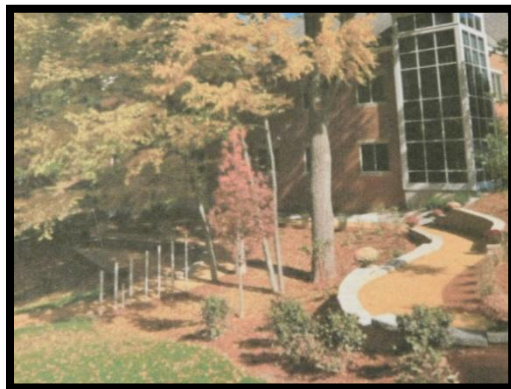
- Pros:
- 1) Relatively inexpensive
  - 2) Permeable
  - 3) More durable than regular stone dust
  - 4) Doesn't heave, weed resistant
  - 5) Works on sloping surfaces

- Cons:
- 1) Costs more than regular stone dust
  - 2) Requires metal or wood edging to preserve the integrity of the walkway and limit side erosion
  - 3) May require periodic touch up and restoration

***Note:** Upon application the initial color of the surface is yellow, but then weathers over time to silvery gray.*

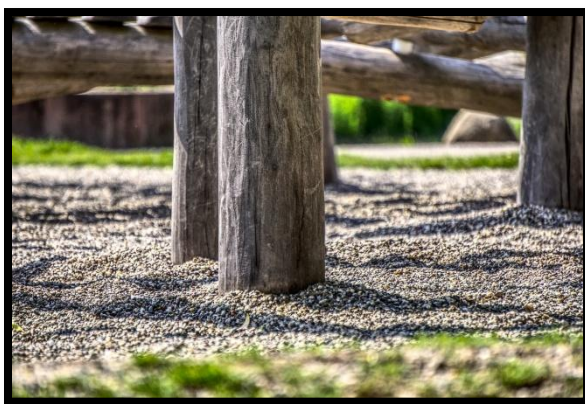
Pros: Pea gravel is inexpensive and easy to maintain. It also allows for good drainage and does not attract animals.

Cons: It can be a hazard if it is thrown by persons in the playground. Some daycare providers have reported that pea gravel fits well in a nostril or an ear, which can result in an unwanted visit to the doctor or emergency room. It also creates a problem for maintenance of the grass and surfaces surrounding the playground. Lawn mowers can throw the gravel significant distances. The material cannot be used if the fall height within the playground is greater than 5 feet.

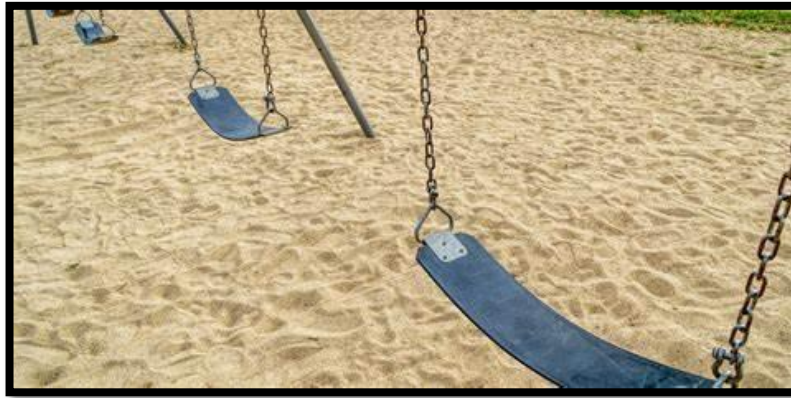
#### **Sand**

Pros: Sand is a very easy product to maintain through simple raking and leveling. . It is also a preferred material to play in by children.

Cons: Cats often use the sand as a litter box which creates a serious health code concern. Broken glass and other debris can also become buried in sand, invisible to the eye, resulting in potential future injuries. Furthermore, in freezing conditions, sand can become as hard as concrete and can only be used after the sun warms the surface or the material is loosened manually. Sand cannot be used if the fall height within the playground is greater than 4 feet.

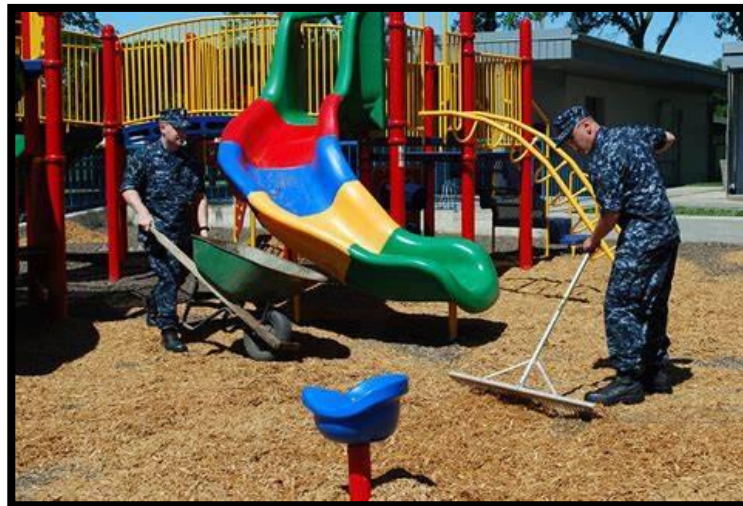
#### Regular Wood Chips (not engineered wood fiber)

Pros: This material is inexpensive, readily available, and easily moveable. It is typically also a good fall attenuating surface material. If properly maintained, wood chips can be used as a fall zone for play structures with a fall height up to 10 feet.

Cons: Regular wood chips require constant maintenance. They must be turned over occasionally to prevent decomposing and do not have good drainage qualities. Typically, a significant amount of the material, 25% or more, must be replaced annually.

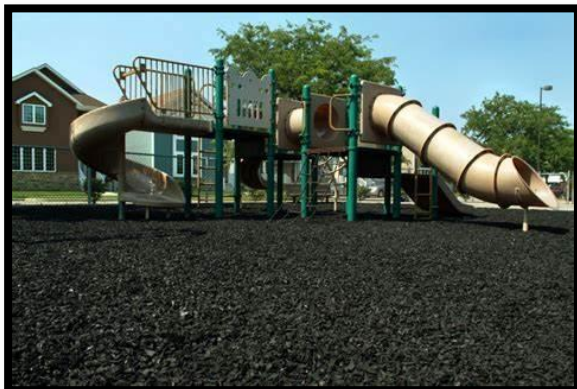
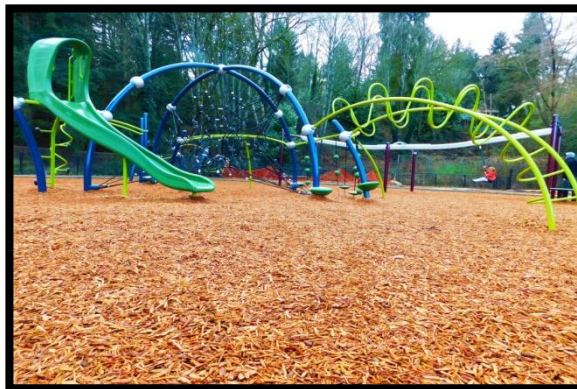
#### Shredded Rubber and Engineered Wood Fiber

Pros: These products are ADA-approved for impact attenuation and are relatively cost efficient. Shredded Rubber and Engineered Wood Fiber can be used for play structures with a fall height up to 10 feet.

Cons: These materials have the potential to “off-gas” in high temperatures. They are also difficult to keep in the play areas, out of the grass, and out of children’s clothes.

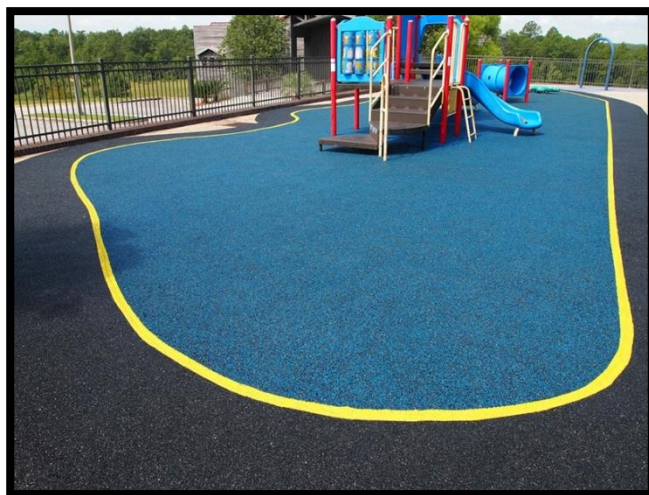
### Pour-in-Place, Rubber Mats/Tiles

Cons: Over time tile edges may “curl”, creating a tripping hazard. Expansion between tiles also allows debris to accumulate, and the surface of the pour-in-place materials can freeze and separate. Consequently, it is difficult to patch the surface for an extended period of time. The biggest problem with these surfaces is the cost, which is significantly more than other acceptable options. In addition, severe and varying weather conditions may reduce the average life expectancy for the pour-in-place materials.

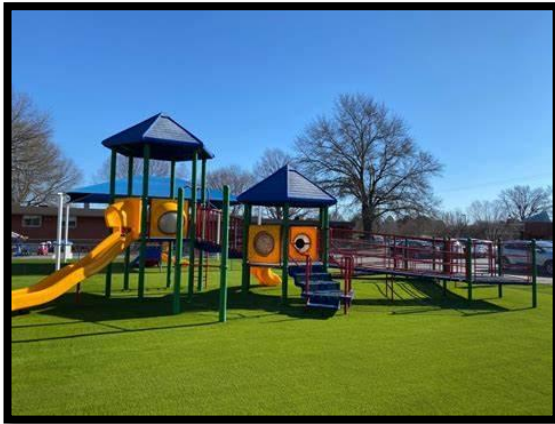
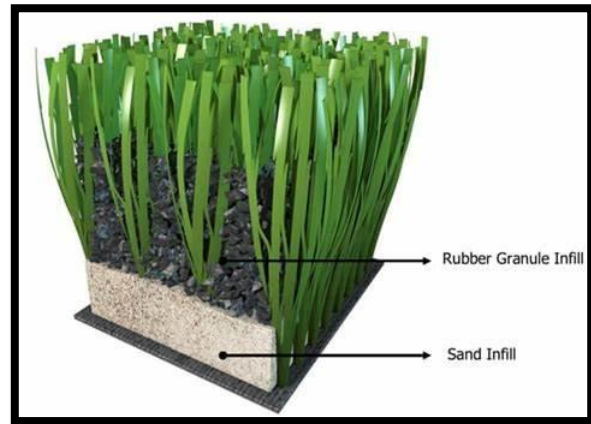
### Artificial Grass with Rubber in-Fill

**Pros:** A properly and independently certified turf should also have a soft, consistent surface that is ADA accessible for easy wheelchair access. Since the grass won't displace like loose fill, such as sand, rubber chips, or wood chips, the safety rating is easy to maintain, even under play equipment. Artificial grass installed over a proper base can provide an ASTM safety rating for fall heights up to 12 feet.

**Cons:** Although artificial grass with a rubber infill is significantly more expensive than the cost of loose fill material, it is typically less expensive than pour-in-place surfaces.

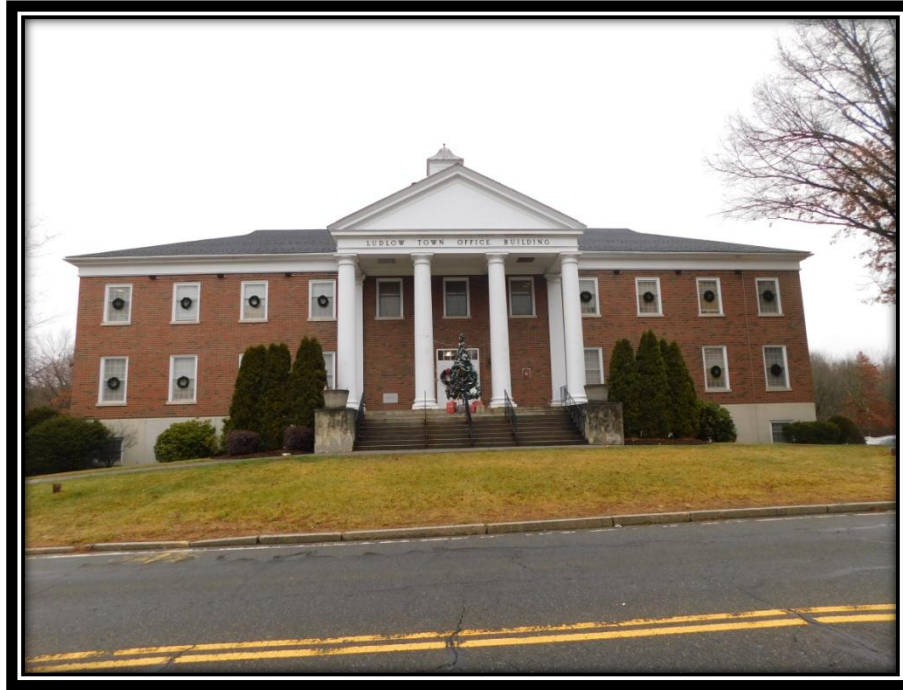
**Function and Description of Facility and Programs:** The Town Hall is a 3-story, wood frame and brick veneer building that was constructed in 1973. The roughly 16,500 s.f. building, located at 488 Chapin Street, houses the town's municipal offices

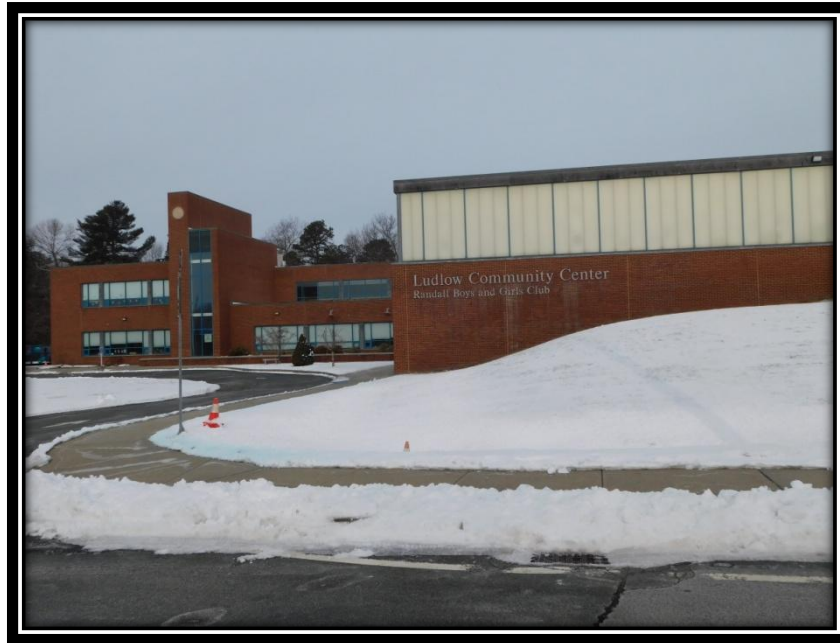
**Function and Description of Facility and Programs:** The Ludlow Community Center/Randall Boys & Girls Club operates out of a 2-story, roughly 40,400 square foot building that was constructed in 2001. The facility provides programs and services to both youth and adults in Ludlow and the surrounding communities. The building consists of administrative offices, 3 Pre-Kindergarten classrooms, a game room, a staff break room, a gymnasium, a pool, locker rooms, a fitness room, 3 youth program rooms, and bathrooms.

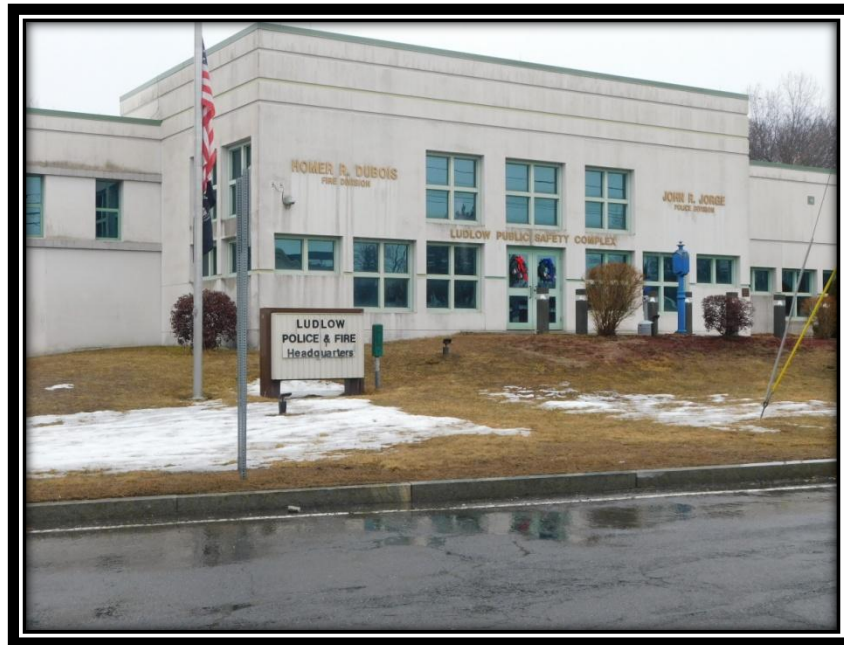
The Police Department Headquarters consists of 2 levels. The main level contains the offices, kitchenette, interview rooms, dispatch center, holding cells, booking area, bathrooms, and garage/sally port. The lower level contains the break room, fitness room, and officer showers.

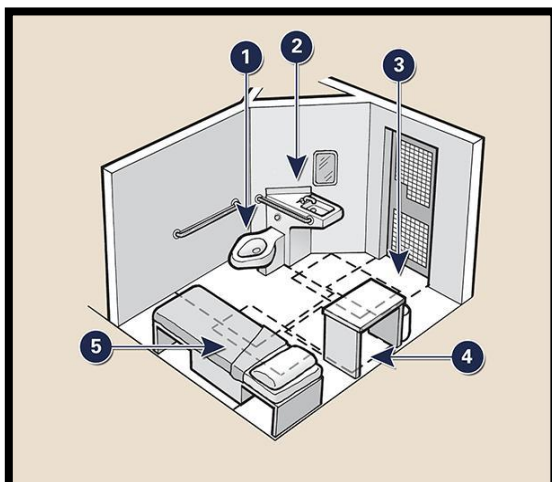
Rendering of ADA Compliant Cell

For illustrative purposes, a typical room layout and general features of an accessible cell is shown below.

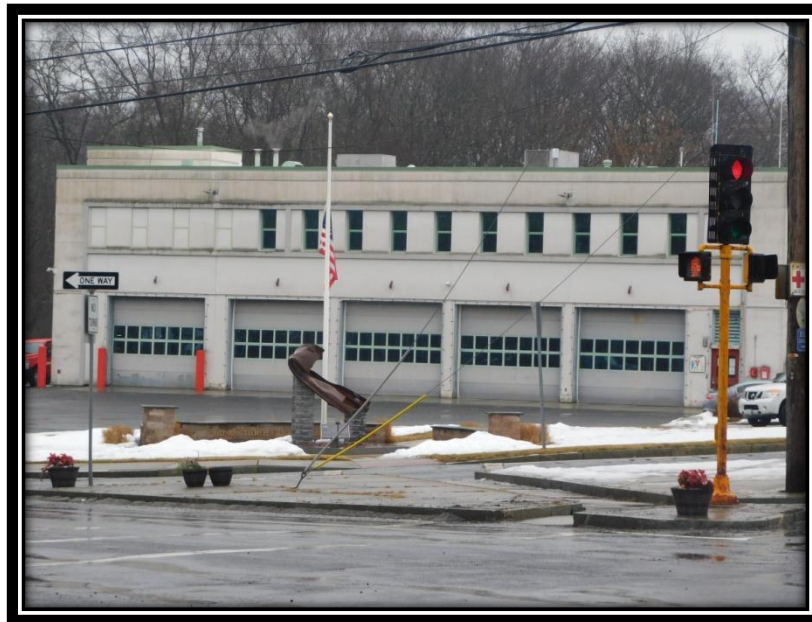
The Fire Station/Headquarters consists of 2 levels. The upper level contains the offices, break room, conference room, day room/kitchen, bunk rooms, lockers, and bathrooms. The lower level contains the apparatus bays which house the fire apparatus and related equipment.

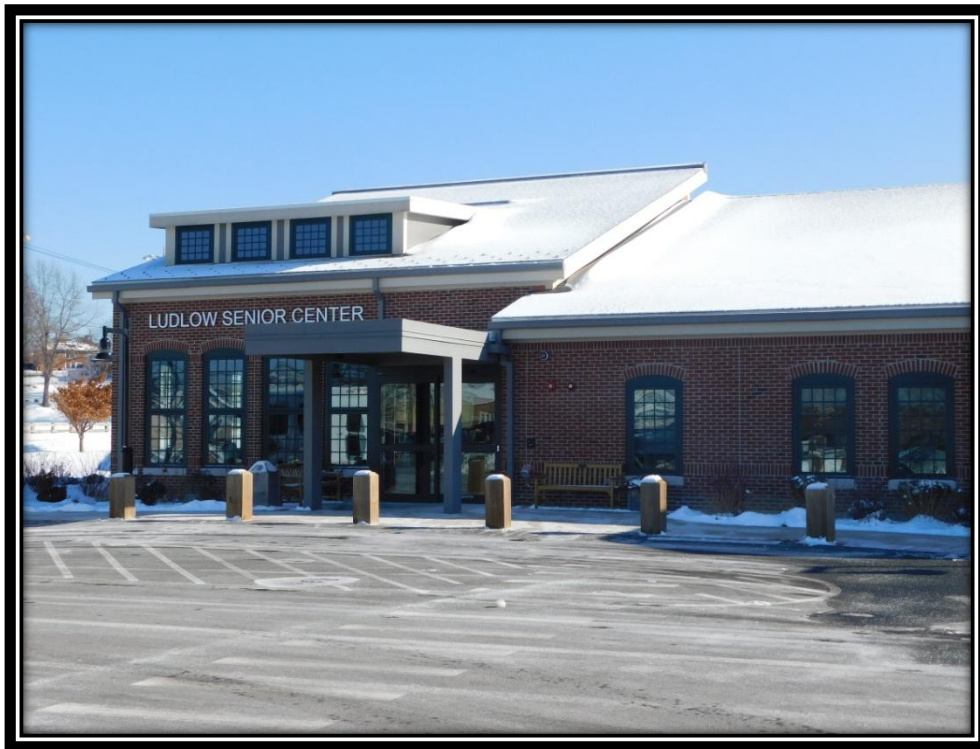
**Function and Description of Facility and Programs:** The Senior Center/Council on Aging coordinates and operates senior-oriented comprehensive day to day services for Ludlow residents age 60 and over. The Senior Center works on behalf of the older residents of the town to make sure that adequate services and activities are available. Programs are designed to improve and enrich the quality of life for the elderly. They include, but are not limited to, information/referral, nutrition counseling, outreach, transportation, health and foot care clinics, advocacy, daily meals, and numerous social activities. The Senior Center is a one-story, roughly 17,692 sf masonry building that was completed in 2020. The building consists of administrative offices, a small café, a dining/large meeting room, a kitchen, a billiards room, a game room, a small boutique/gift shop, a fitness studio, an exercise room, a wellness room, a small conference room, an arts and crafts room, and bathrooms.

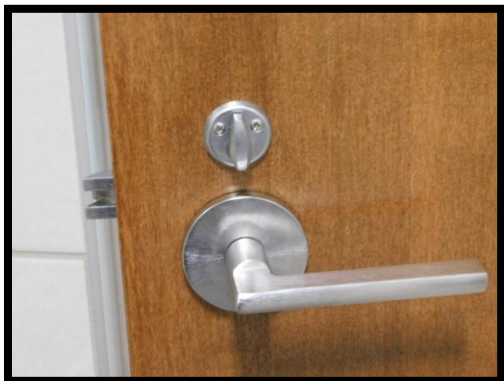
Photo Senior 8 (Recommended Locking Mechanism)

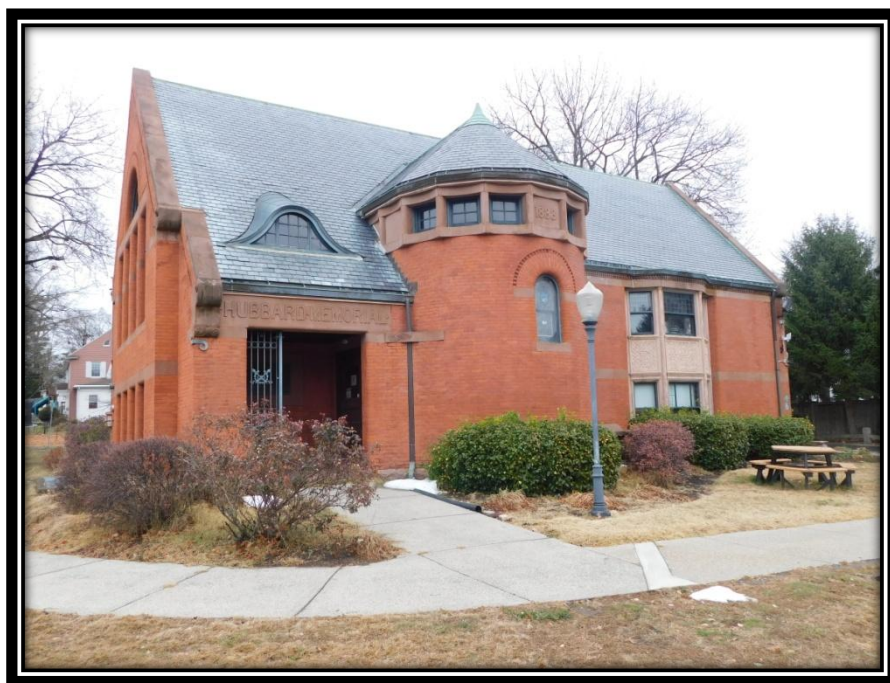
**Function and Description of Facility and Programs:** Hubbard Memorial Library is included in the National Register of Historic Places as a part of the Ludlow Village Historic District. Originally constructed in 1888, the building has undergone renovations and expansions including addressing overall accessibility and usability of the library. The 3-level (lower level, main floor, upper level), masonry building is roughly 12,400 s.f. The Lower Level contains adult stacks. The Upper Level contains the children's and young adult rooms, a program room, a conference room, a staff kitchenette, and 2 public non-accessible bathrooms. The Main Level includes circulation, reference, tables for work/reading, periodicals and CD's, computers, a staff area, a staff kitchenette, a staff bathroom, and 2 public accessible bathrooms.

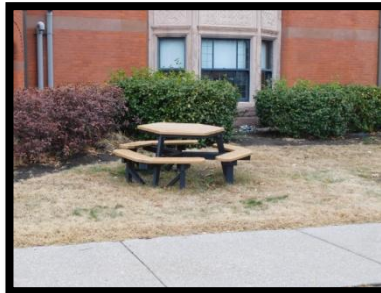
Photo Library 2

<b><u>Picnic Table</u></b> A picnic table is not on an accessible route of travel, has only 26" of knee clearance, and only 7½" of clear width.  See Photo Library 2.	226.1 902	19	Provide an additional picnic table which provides the required 27" knee height, 30" clear width, and 19" knee depth and locate on an accessible route of travel.	2	2	I	\$750
<b><u>Exterior Accessible Route of Travel</u></b> The concrete walkway from the accessible parking to the entrance has areas of abrupt changes in level surface and areas of deterioration. The sloped concrete pad leading to the entrance approach has a running slope of up to 8.2% for approximately 6 feet. In addition, there are cross slopes of 2.6% to 2.8%. There is also a ½" abrupt change in level surface at the transition in concrete to the sloped walkway into the building.  Although the grates at the base of the sloped walkway in front of the entrance has ½" wide openings, they vary in length from 3½" to 5" and are not perpendicular to the route of travel.  See Photos Library 3, 4, 5, 6, and 7.	403  302.3	22  22.7	The walkway should be modified and/or reconstructed to eliminate the abrupt changes in level surface and areas of deterioration through grinding or concrete patching. The pads with excessive running and cross slopes should be replaced and set to ensure that the running slopes do not exceed 5.0% and the cross slopes do not exceed 2.0%.  Replace the grates with ones that have the elongated opening perpendicular to the route of travel.	1  1	3  3	N  N	Up to \$500  TBD

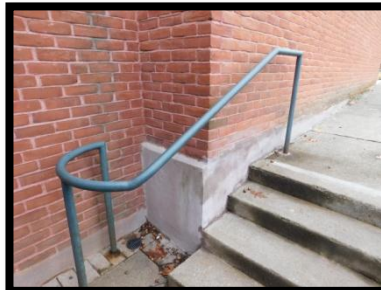
Photo Library 8

<b><u>Exterior Stairs</u></b> The exterior stair railing on the building side at the entrance is 33" a.f.f., which is 1" too low.  See Photo Library 8.	505.4	27.4.2	Option #1: Seek a variance to retain the existing railing due to the cost vs. the benefit gained.  Option #2: Replace or modify the railing so it is 34" to 38" a.f.f. to the top of the gripping surface.	1  1	1  3	I  L	\$0  Up to \$2,500+
<b><u>Doors and Clear Widths</u></b> Doors with closers have excessive opening forces and close too fast.  The following doors and rooms lack tactile designation signage:	404.2.8 404.2.9  703	26.8 26.9  41.1	Adjust door closers such that the push/pull force does not exceed 15 lbs. for an exterior door and 5 lbs. for an interior door with door closing speeds of at least 6 seconds.  Install accessible compliant signage on the latch side of each door with appropriate finish and contrast and character height and proportions, raised and brailled	2  2, 3	2  1	I  I	\$0  \$1,000

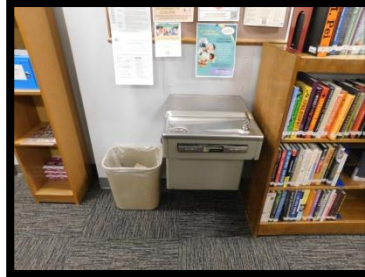
Photo Library 17

<p><b>Drinking Fountains</b></p> <p>A drinking fountain on the Main Level and Upper Level are "low" only and provide only 23 ½" of knee clearance.</p> <p>See Photo Library 17.</p>	211	36	<p>Option #1: Discontinue use of the drinking fountains.</p> <p>Option #2 – Remove the existing drinking fountains and replace with "hi-low" drinking fountains. The drinking fountains must comply as follows:</p> <p>Protruding objects compliance of no &gt; 4" protrusion between 27" and 80" a.f.f. (307); 30"x48" clear space requirement (305), and knee/toe clearance (306). Knee clearance is 9" to 27" a.f.f.; 25" deep max. at 9" a.f.f. or 11" deep min at 9" a.f.f. and 8" deep min at 27" a.f.f. Width of knee clearance s/b 30" wide min (306.3). Toe clearance as part of c.f.s. 17" min – 25" max, 9" high a.f.f., 30" wide (306.2). The spout s/b 15" min from wall and 5" max from the front edge of the unit (602.5). Flow of water 4" high min and spout located max 5" from front (602.6). and with the water flow within 3" from the front edge (36.3). The spout height s/b 36" max. a.f.f. for "low" and 38" min a.f.f. to 43" max a.f.f. for "high". The controls s/b operable w/one fist; no &gt; 5 lbs force (309.4).</p>	2	3	N	Up to \$10,000+

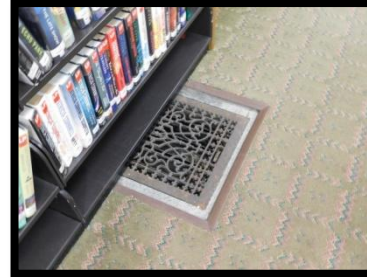
Photo Library 18

<b>Floor Grates</b> A floor grate on the Main Level has excessive openings that also are not perpendicular to the route of travel.  See Photo Library 18.	302.3	22.7	Replace the grate with one that has openings of no greater than ½" and which is perpendicular to the route of travel.	4	2,3	N	Up to \$350+
<b>Carpeting and Rugs</b> A rug in the Conference Room is unsecured and serves as a tripping hazard.	302.2	29.3	Remove or secure the rugs/carpets.	4	2	I	\$0
<b>Staff Sinks</b> The Main Level and Upper Level staff sinks/counters are 2" too high and lack knee clearance.  See Photo Library 19.	804.3.2 606.3 306.3	32.2 32.6	As may be requested as a result of a reasonable accommodation request, the counters and sinks would need to be modified so that they are no more than 34" a.f.f. and there is a minimum of 27" knee clearance at the sinks with guarded, wrapped, or insulated piping.	2	3	L	TBD
<b>Interior Stairs and Railings</b> The newer stairs to connect the 3 levels have bottom extensions that only go the slope distance of 8" (not the full width of a stair tread) and only extend 8" parallel to the floor, not the required 12".  The railings are 31" to 32" a.f.f. to the top of the gripping surface and not the required 34" to 38" a.f.f.	505.10  505.4	27.4.3  27.4.2	Seek a variance to retain the existing railings due to the cost to modify and/or replace the railings which would be in the hundreds of thousands of dollars vs. the benefit gained.	1	1	I	\$0

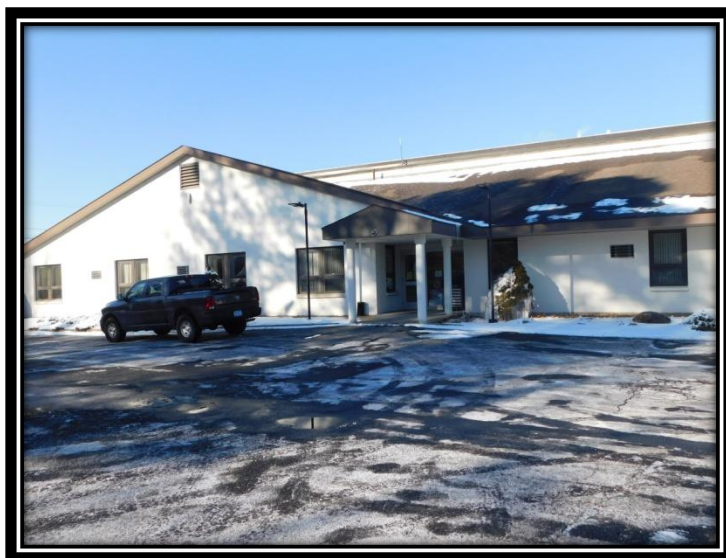
The DPW Building is a one-story, roughly 15,800 s.f. building constructed in 1978 that houses the administrative offices of the various divisions as well as a large apparatus bay, shop area, a locker room, employee lunch room, and bathrooms. There are also a number of outbuildings, storage sheds, and a salt storage shed on the site. These areas have controlled access behind the main DPW building and are not open to the public.

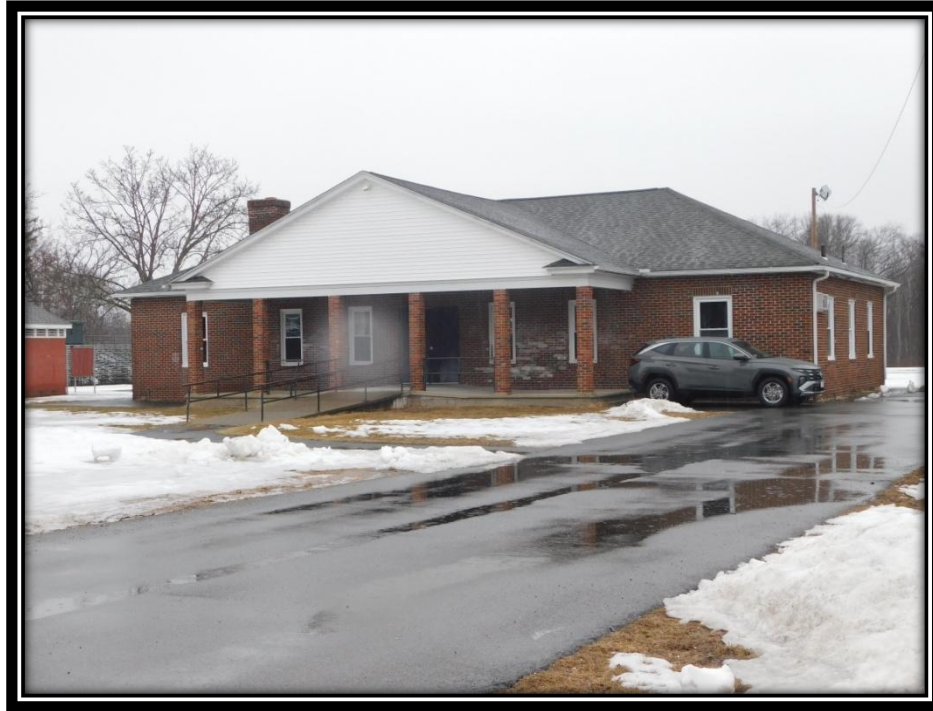
**Function and Description of Facility and Programs:** The Recreation Department Building is a one –story masonry structure totaling roughly 2,450 square feet. The building consists of a large open area, an office, 2 bathrooms, and storage rooms.

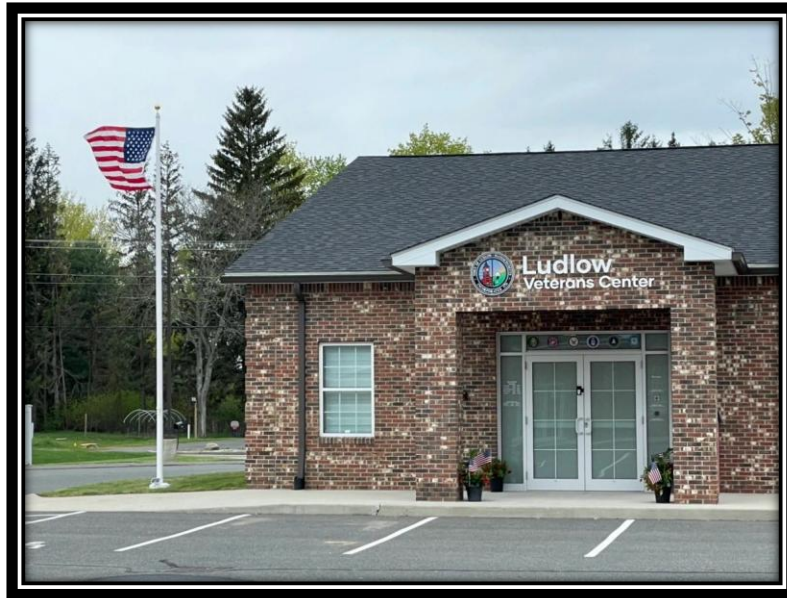
**Description of Facility and Programs:** The Veteran's Center is located at 487 Holyoke Street in a commercial plaza. The building is a one-story masonry building which includes a number of offices, bathrooms, and a large meeting room/food storage area.

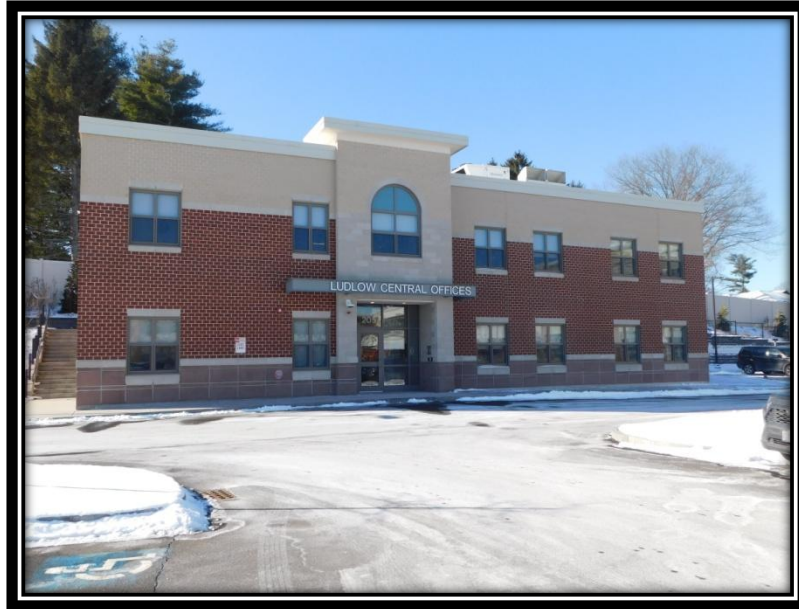
**Description of Facility and Programs:** The Ludlow School Central Office Building is located adjacent to Harris Brook Elementary School on Fuller Street. The building is a 2-story, roughly 6,400 sq. ft. masonry structure that was constructed in 2021.

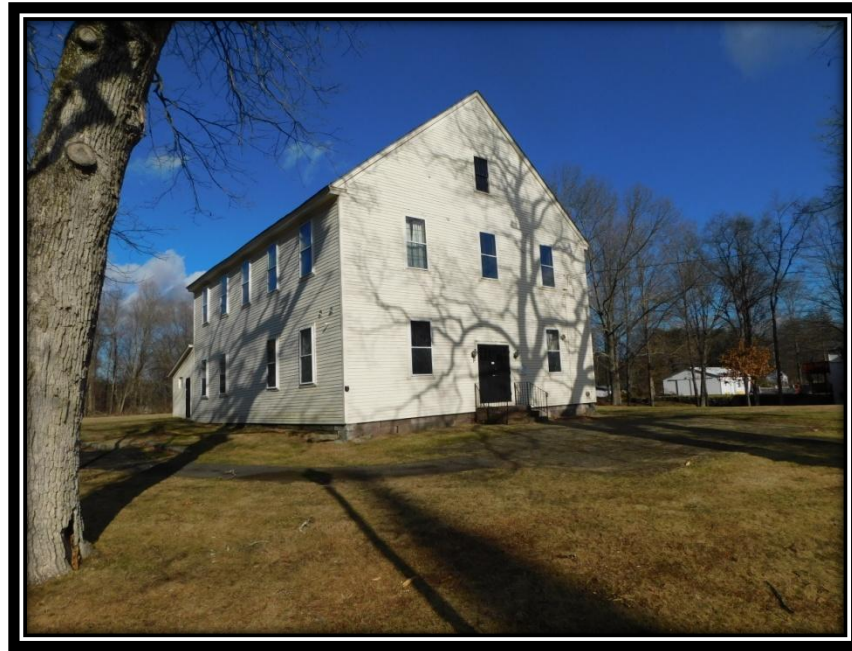
**Description of Facility and Programs:** The Ludlow Grange Building is a 2-story wooden frame structure that was built in 1783. The building is within the Ludlow Center Historic District which is listed on the National Register of Historic Places.

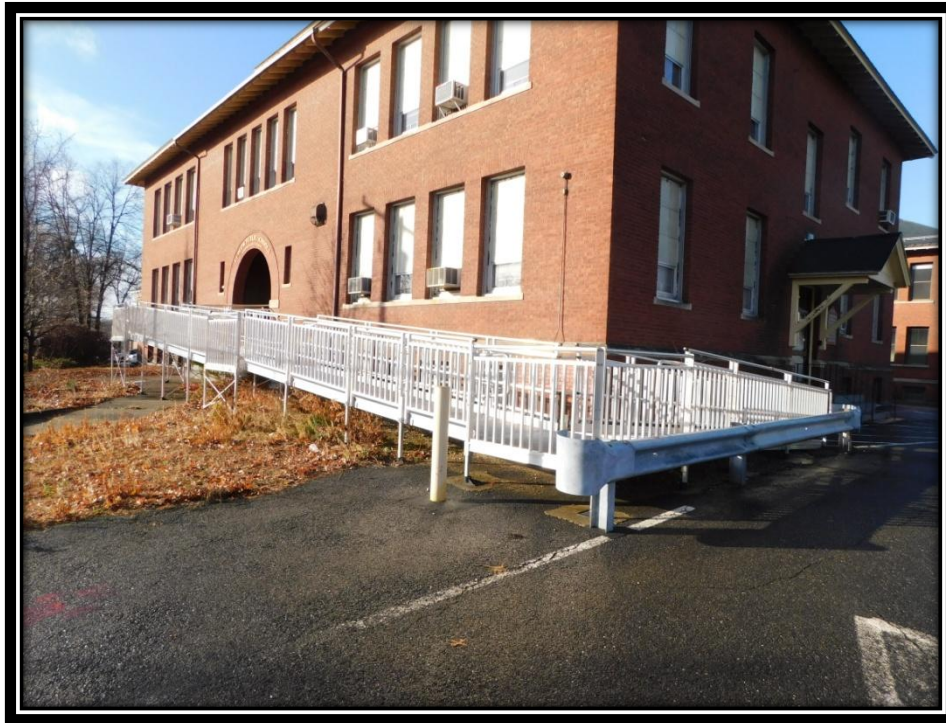
**Function and Description of Facility and Programs:** The Former School Administration Building is located at 63 Chestnut Street. The building is a 2-story 12,068 s.f. masonry building that was built in 1882. There is also a partially finished basement. The building is currently vacant.

**General Description or Obstacle Which Limits Mobility or Access:** The building is predominately non-compliant under both the 2010 ADA Standards for Accessible Design and the 521 CMR Massachusetts Architectural Access Board Regulations.

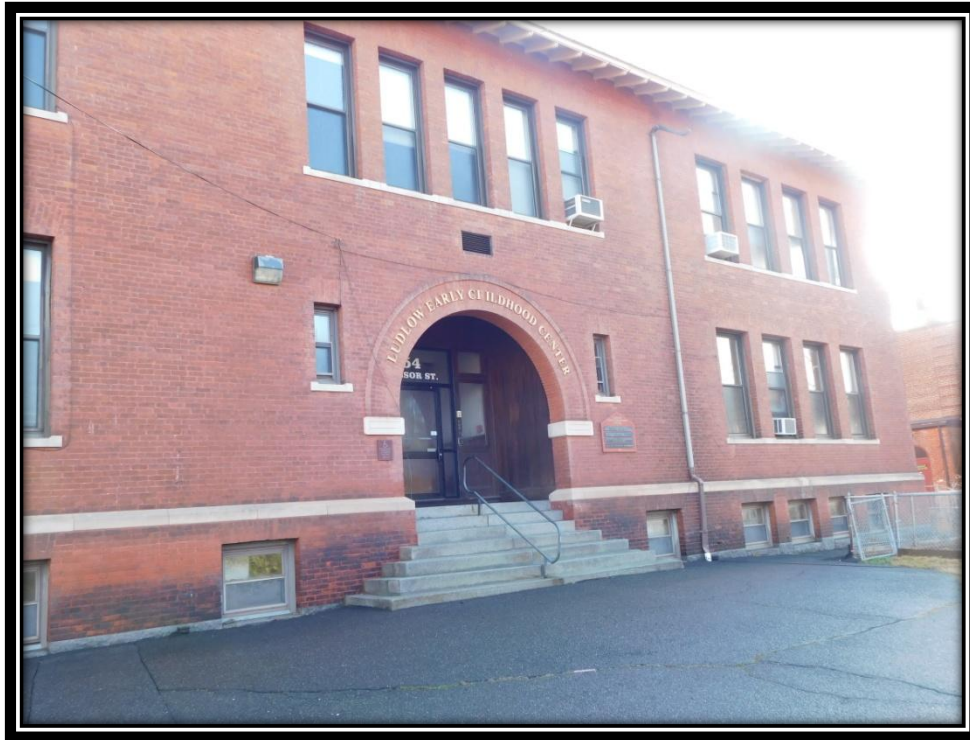
**Function and Description of Facility and Programs:** The Head Start Building is located at 54 Winsor Street. The building is a 2-story 12,068 s.f. masonry building that was built in 1882. There is also a partially finished basement. The building is currently vacant. An elevator does provide vertical access to all 3 levels of the building.

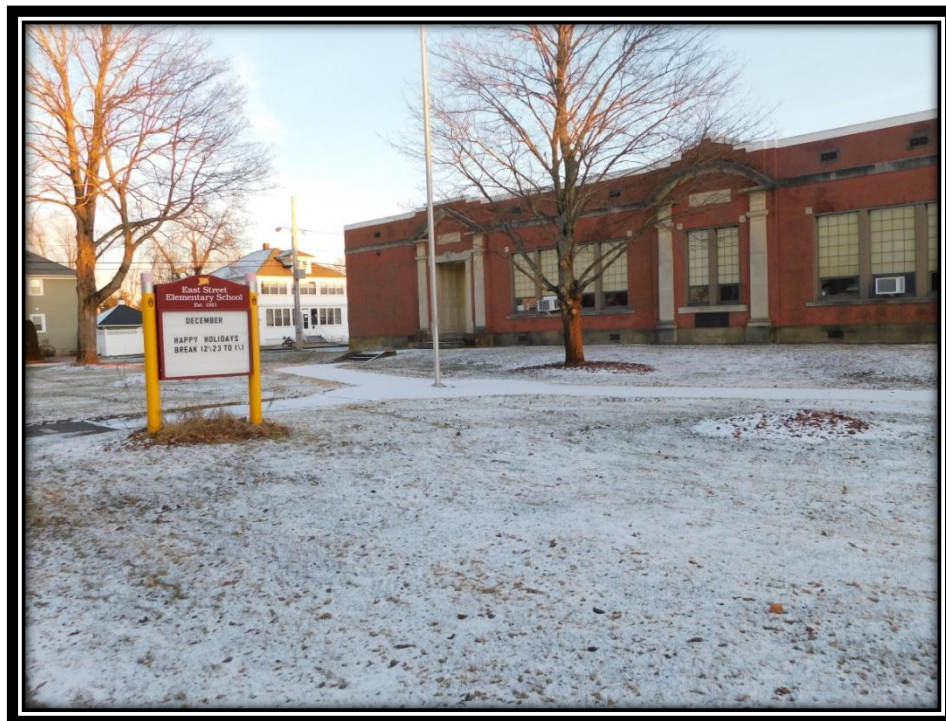
**Description of Facility:** East Street Elementary School is a masonry 2-story building which serves as a public school for Pre-kindergarten to Grade 1. The roughly 72,800 s.f. building was originally constructed in 1921 and had subsequent additions in 1959 and 1992.
