## **A. SSO Inventory (from Town of Ludlow IDDE)**

**Town of Ludlow BMP Tracking**

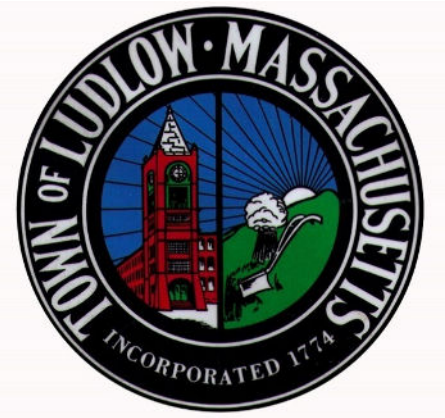
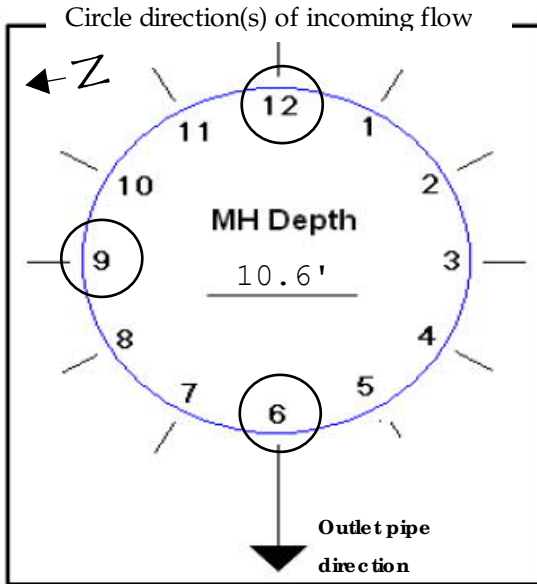
| <b>Structure ID</b> DMH_690 | <b>Last Rain Date/ Amount</b><br>26 Aug 2022: 0.29in |

| <b>Location Description</b> East St / Park Place<br>42.157176° -72.483687° | |

| Clock Position (1-12)<br>Pipe Material (Concrete, HDPE, PVC, Ductile Iron, CMP) | Pipe Diameter (in.) | Invert Elevation (ft) | Upgradient Structure/ Source (MH ID, CB, Priv, Unk) | Flow (Damp, Trickle, Moderate, High) |
|---|---|---|---|---|
| (6) RCP | 36 | 10.6' down from rim | MH | Damp |

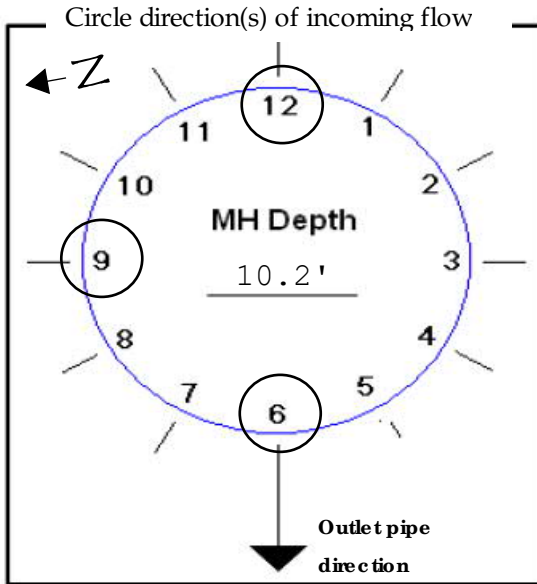
| <b>Location Description</b> East St / Chestnut St<br>42.156802° -72.482472° | |

| Clock Position (1-12)<br>Pipe Material (Concrete, HDPE, PVC, Ductile Iron, CMP) | Pipe Diameter (in.) | Invert Elevation (ft) | Upgradient Structure/ Source (MH ID, CB, Priv, Unk) | Flow (Damp, Trickle, Moderate, High) |
|---|---|---|---|---|
| (6) RCP | 36 | 10.2' down from rim | MH | Damp |

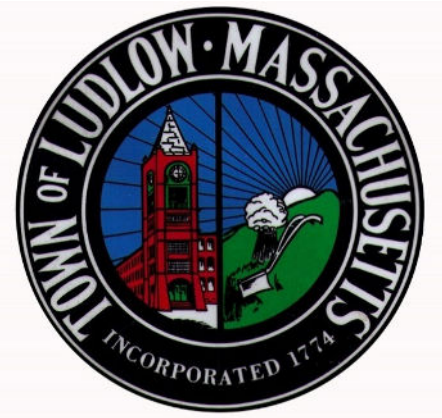
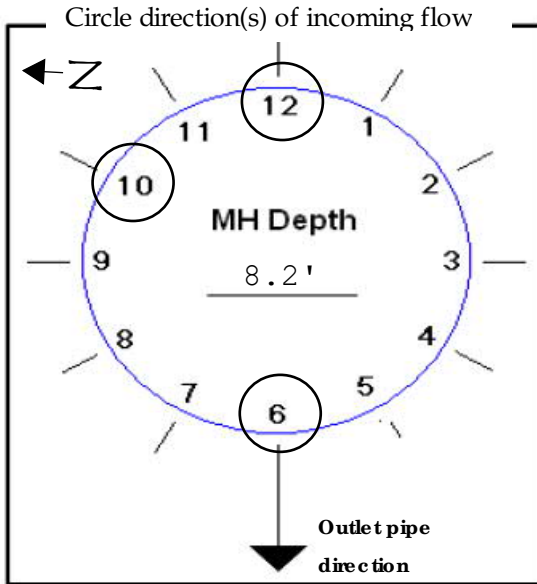
| <b>Structure ID</b> DMH_696 | <b>Last Rain Date/ Amount</b><br>2 Aug 2022: 0.12in |

| <b>Location Description</b> East St / Sewall St<br>42.156577° -72.481312° | |

| Clock Position (1-12)<br>Pipe Material (Concrete, HDPE, PVC, Ductile Iron, CMP) | Pipe Diameter (in.) | Invert Elevation (ft) | Upgradient Structure/ Source (MH ID, CB, Priv, Unk) | Flow (Damp, Trickle, Moderate, High) |
|---|---|---|---|---|
| (6) RCP | 36 | 8.2' down from rim | MH | Dry |

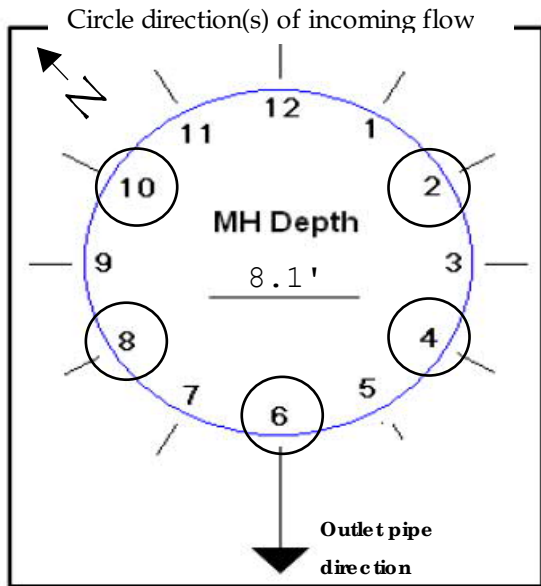
| <b>Location Description</b> | Winsor St / Park Place<br>42.159049° -72.482758° | | |

| Clock Position<br>(1-12)<br>Pipe Material<br>(Concrete,<br>HDPE, PVC,<br>Ductile Iron,<br>CMP) | Pipe<br>Diameter<br>(in.) | Invert<br>Elevation<br>(ft) | Upgradient<br>Structure/ Source<br>(MH ID, CB,<br>Priv, Unk) | Flow<br>(Damp, Trickle,<br>Moderate,<br>High) |
|---|---|---|---|---|
| (2) RCP | 15 | 7.9' down<br>from rim | MH | Dry |
