HARRIS BROOK ELEMENTARY SCHOOL

Description of Facility: Harris Brook Elementary School is a masonry 2-story building which serves as a public school for Grades 2 – 5 serving approximately 600 students. The roughly 115, 00 s.f. building was constructed in 2021.

Harris Brook Elementary School Accessibility Assessment Photos

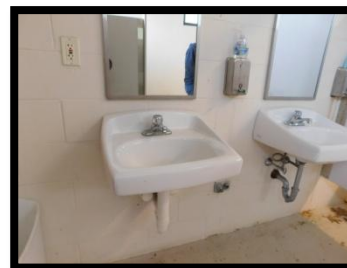
Photo Haviland 6

<u>Men's Bathroom Only</u> The water closet has the flush control on the wrong side. See Photos Haviland 6, 7, and 8.	604.6	30.7.5	Modify/replace the water closet such that the flush control is on the wide or approach side.	3	3	N	Up to \$750
---	-------	--------	--	---	---	---	-------------

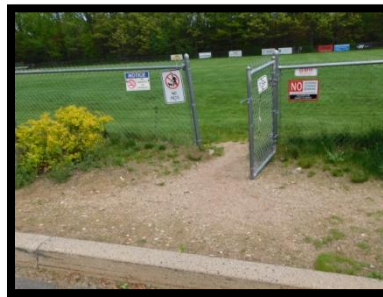
Photo Center 2

<p>Approximately 4 concrete pads from the shuffleboard ramp to the basketball entrance have cross slopes that vary up to 3.2%.</p> <p>See Photos Center 2, 3, 4, 5, 6, 7, and 8.</p>	405.3	24.2	Replace/reset the concrete pads such that the cross slopes do not exceed 2.0%.	2	3	N	Up to \$5,000+
<p><u>Basketball Court Stairs</u></p> <p>The stairs to the basketball court has a railing on only one side. Although the railing lacks a bottom extension, if an extension were added, it would protrude into the sidewalk, therefore none is required.</p> <p>See Photo Center 9.</p>	505	27.4	Install an additional railing on the opposite side of the stairs compliant with S. 505 of the 2010 ADA Standards and S. 27 of 521 CMR.	2	3	N	Up to \$1,200+
<p><u>Gates</u></p> <p>The following gates are smooth at the base on the push side:</p> <ul style="list-style-type: none"> to the splash pad and pavilion to the soccer field to the shuffleboard area (2) to the basketball court to the front playground (2) <p>See Photos Center 10 and 11.</p>	404.2.10	NA	Install smooth plating or a covering at the base of the gates on the push side to a height of 10" from the ground.	2	2	I	\$700

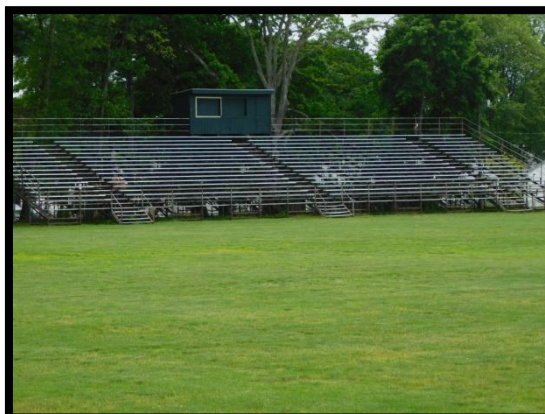
Photo Whitney 10

Football Broadcast Booth The broadcast booth is not on an accessible route of travel. There is a 14" rise or step into the building. The door hardware requires the use of fingers and pinching/twisting.	206 404.2	14 26.11	Option #1: Seek a variance to not require the provision of an accessible route to the broadcast booth due to its use and limited size (120 square feet). Replace the hardware with lever style hardware.	2	1	I	\$0

See Photo Whitney 10.			<p>Option #2: Discontinue use of the Level 2 broadcast booth.</p> <p>Option #3: Install a vertical wheelchair platform lift to the broadcast booth. Replace the hardware with lever style hardware.</p> <p><u>Additional Comment</u> Although the 2010 ADA Standards do allow for an "exception" requiring an accessible route to press boxes/broadcast booths that are free-standing, above grade no more than 12 feet, and less than 500 sq. ft. in size; 521 CMR does not.</p>	2	1	I	\$0
				2	3,4	L	Up to \$100k+
<p>Accessible Route of Travel</p> <p>There is no accessible route of travel to the (two) 2 playground areas, benches, swings, ground components, shuffleboard, "little library", tennis courts, canopy/pavilion, football field and bleachers, baseball fields and players seating, baseball field bleachers, baseball field drinking fountain, pitching/batting cage, and to Memorial Pool from the baseball field.</p> <p>The exiting surfaces vary including loose stone, grass, and dirt.</p> <p>There are no level areas for wheelchairs at the benches at the playground and baseball field.</p> <p>See Photos Whitney 11 - 20.</p>	206 402 403 221 802	20 22 14 19	<p>An accessible route of travel needs to be provided to all areas available to the public. Construct an accessible route of travel fully to the (two) 2 playground areas, benches, swings, ground components, shuffleboard, "little library", tennis courts, canopy/pavilion, football field and bleachers, baseball fields and players seating, baseball field bleachers, baseball field drinking fountain, pitching/batting cage, and to Memorial Pool from the baseball field.</p> <p>The accessible route of travel must be compliant with width (48" per 521 CMR) and slope (2% max. cross, 5% max. running) requirements as well as changes in level surface (no > than ¼" unbeveled or between ¼" and ½" beveled w/a slope of no > 1:2). Construction options include compacted stone dust, asphalt or similar surfaces that meet the requirement of stable, firm, and slip resistant. Costs will vary depending on material used.</p> <p>Create an approach and level wheelchair area next to the benches. The spaces should be 36" wide x 60" deep per wheelchair. If a front/rear approach, the depth can be reduced to 48" as opposed to 60" for a side approach.</p>	2	3	N	Up to \$75,000+

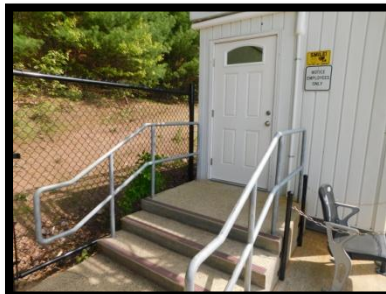
Photo Fields 16

<p>The door lacks tactile designation signage, has knob style hardware, and has a glass pane that is 68¾" a.f.f.</p> <p>See Photo Fields 16.</p>	703 404.2 309.4 404.2.11	41.1 26.11	Install tactile designation signage on the latch side of the door. Replace the knob hardware with lever style hardware. As the door is not on an accessible route of travel, modifications to the glass pane are not required.	2	2	I	\$125

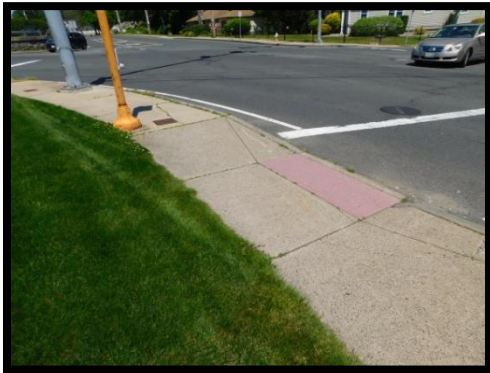
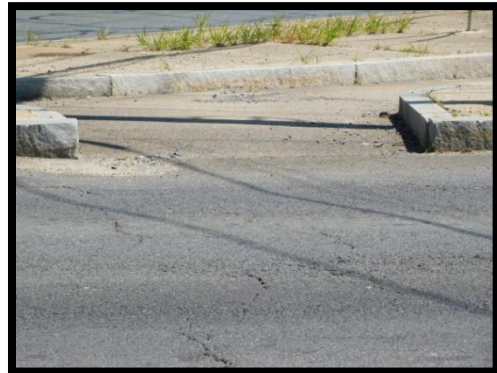
Crosswalk across Chapin Street at Center Street

- There is no level landing at the top of the curb ramp on the sidewalk side (odd numbered) of Chapin Street.
- There are no detectable warning strips in the center island and no level landings.
- There is no level landing at the top of the curb ramp on the Public Safety Complex side.

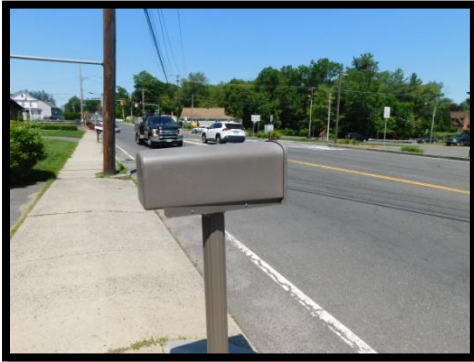
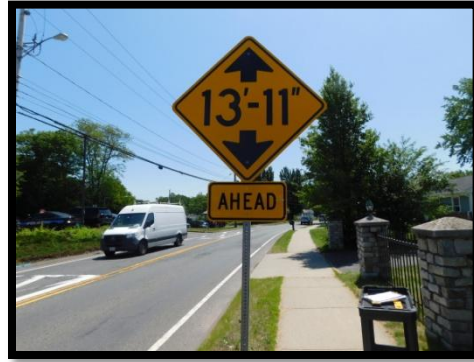
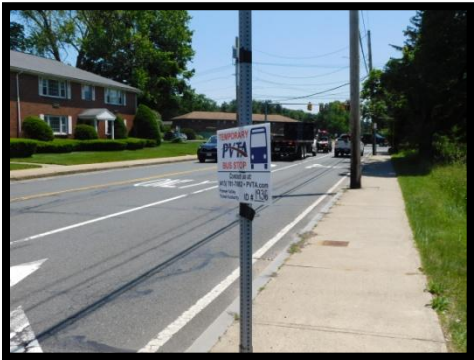
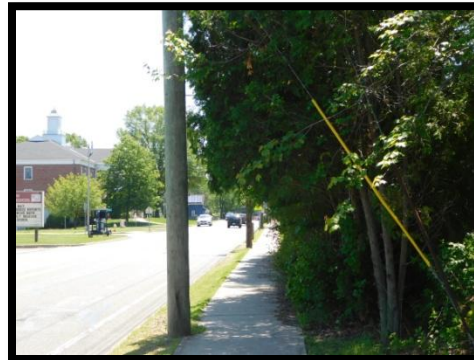
Protruding Objects and Reduced Headroom

The following protrude into the accessible route of travel more than 4" at a height of between 27" and 80" or have reduced headroom of less than 80":

- Mailbox near House #607 (6" protrusion at 42" a.f.f.).
- 30 MPH sign near House #607 (10 1/2" protrusion at 72" a.f.f.).
- Mailbox near House #605 (6" protrusion at 45" a.f.f.).
- Mailbox near House #601 (8" protrusion at 41 1/2" a.f.f.).
- 13' 11" sign near House #597 (11" protrusion at 22" a.f.f.).
- PVTa temporary bus stop sign across from apartment building near East Street (11 1/2" out at 42" a.f.f.).
- Sidewalk across from high school reduced headroom of less than 80" due to vegetative overgrowth.

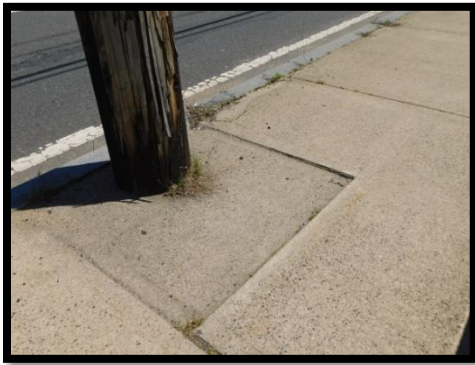
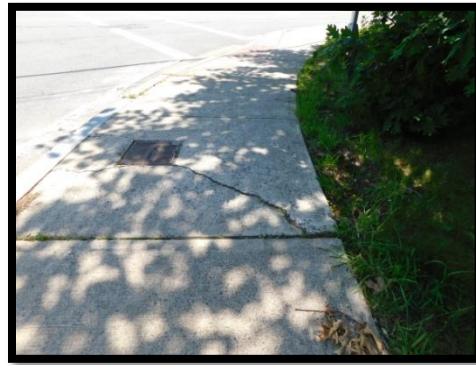
Sidewalk Deterioration and Reduced Clear Widths

- The sidewalk near House #493 has 2 areas of deterioration resulting in abrupt changes in level surface.
- Vegetative overgrowth into the sidewalk near House #417 reduces the clear width to only 32\"/>

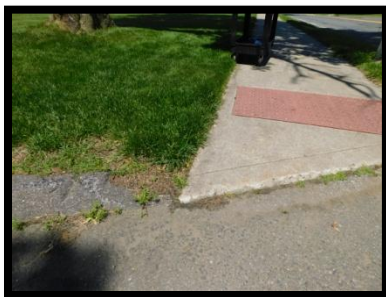
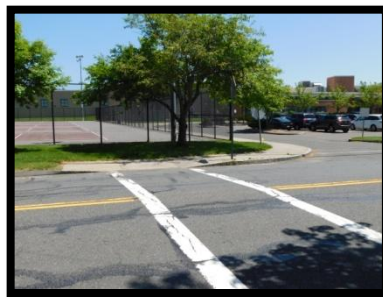
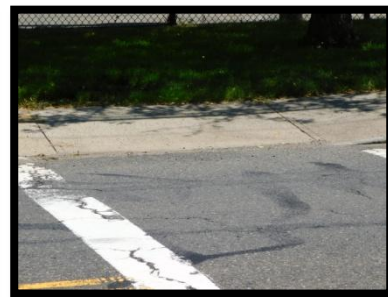
The following curb ramp has up to a 1" abrupt change in level surface:

- Chapin Circle at House #545 side.

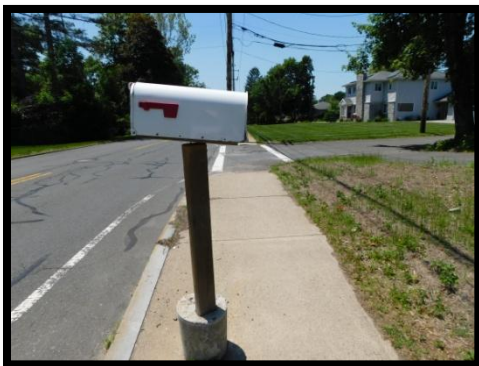
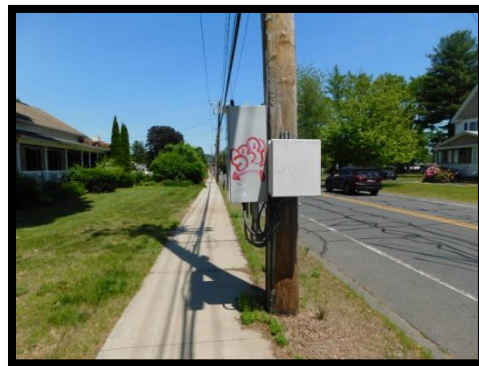
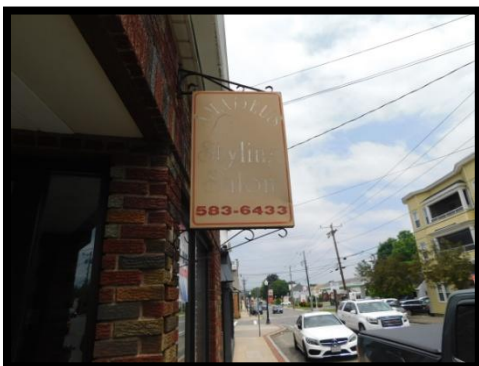
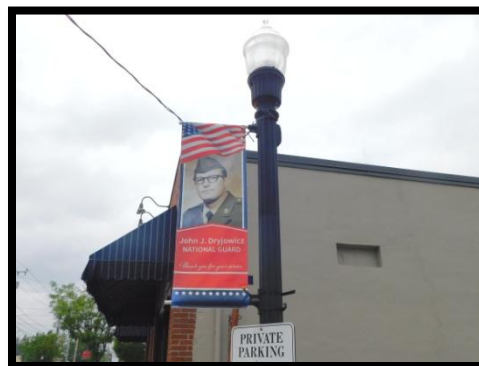
The following protrude into the accessible route of travel more than 4" at a height of between 27" and 80" or have reduced headroom of less than 80":

- Mailbox near House #771 (5" protrusion at 49 1/2" a.f.f.).
- Electric/Utility Box on Pole NYNEX 61/1951-90T across from Tony Lema Drive (16" out at 45 1/2" a.f.f.).
- Amadeus Hair Styling Sign at #283 (20" out with 75" to 80" headroom).
- Veteran's Honor Sign on light pole near Elegant Nails parking (8" out with 74" headroom).

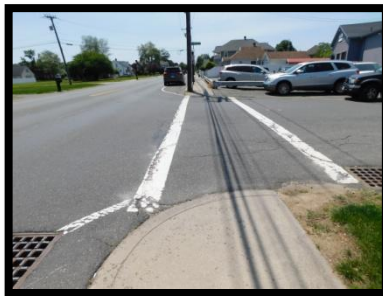
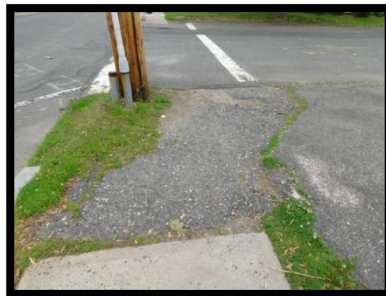
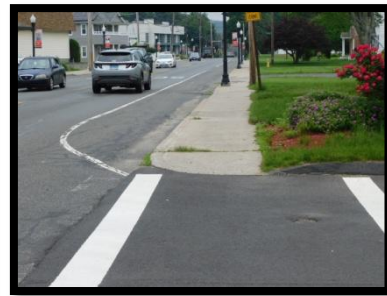
The following curb ramps and crosswalks lack detectable warning strips:

- Brownell Street (on side going to downtown).
- King Street (both sides).
- Amherst Street (both sides).
- Williams Street (both sides).
- Ray Street (both sides).
- Yale Street (on side near church and going to downtown).
- Cedar Street (both sides).
- Pine Street (both sides).
- Kirkland Avenue (both sides).
- Lakeview Avenue (both sides).
- Lockland Street (both sides).
- Prospect Street (both sides).
- Highland Avenue (both sides).
- Hubbard Street (both sides).
- Winsor Street (both sides).
- Winsor Street between #222 and #224 (both sides).

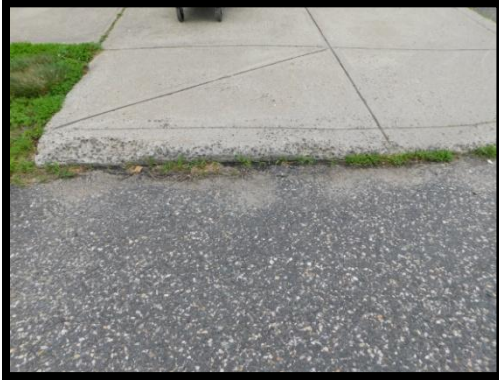
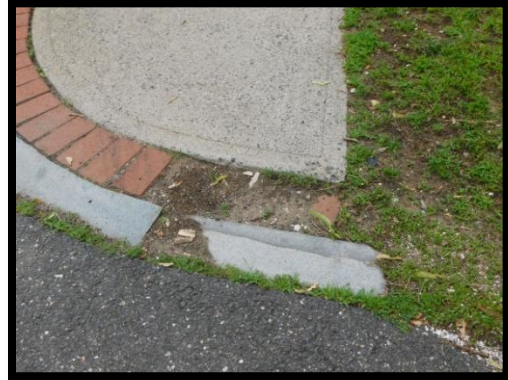
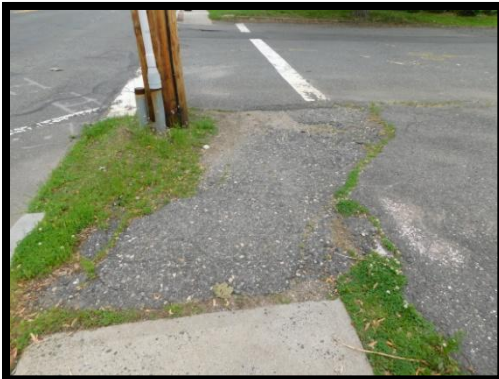
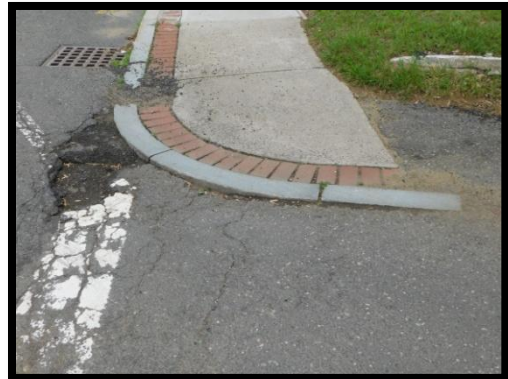
- King Street (#619 side).
- Amherst Street (both sides).
- Ray Street (#535 side).
- Yale Street (Church and #529 side).
- Cedar Street (#477 side).
- Pine Street (#459 side severe deterioration and no formal curb ramp).

- Pine Street (#453 side).
- Hubbard Street (both sides).

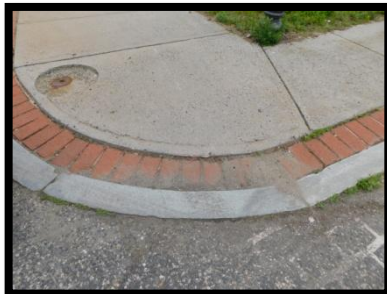
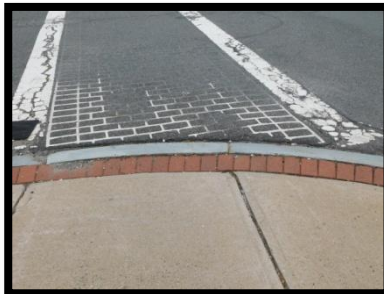
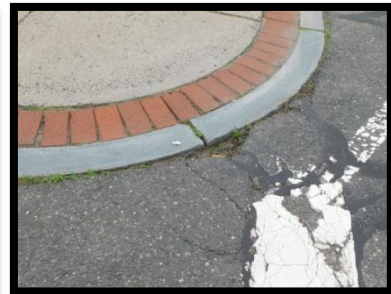
The following curb ramps have 1/2" to 2" abrupt changes in level surface at the transition from roadway (asphalt) to curb ramp (granite, brick, or concrete):

- Palmer Street (Four Seasons Liquor side).
- Brookfield Street (both sides).
- Canterbury Street (#412 side).
- Newbury Street (Funeral Home side)
- Stevens Street.
